# CONSERVATION OF STONEWORK & SCULPTURE

# EASTCOMBE, GLOUCESTERSHIRE : WAR MEMORIAL REPORT ON CONSERVATION WORK CARRIED OUT

May 2018

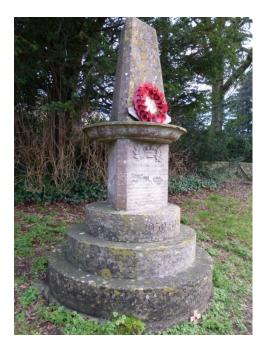
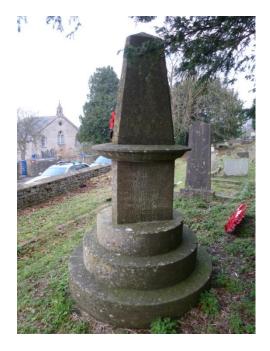
## **BEFORE CLEANING AND REPAIR**

- 2.1 The memorial was largely in good condition, the stonework stable and the pointing intact.
- 2.2 There was a band of decay which follows a fault line sloping across the front face and continuing around the other two sides, although, as these are sheltered, the damage was less severe. It had caused the loss of parts of the lettering on all sides. There was a further minor area of damage towards the base of the front section). These areas had been patched with a hard grey Portland cement mortar which was now failing and pulling away. The carving of a crown has also suffered some damage to the spheres and leaves.
- 2.3 All the lettering is eroding, particularly on the front.
- 2.4 The rest of the surface is in good condition, but was heavily stained with lichen and algae which is increased by the proximity of the yew branches behind.

- 3.1 **Cleaning** Cleaning was achieved using water in handsprays and gentle brushing to remove algal growth, lichen and surface dirt. Traces of black paint were found in some letters.
- 3.2 Repairs and repointing were carried out with a hydraulic lime (NHL3.5) and sand mortar at 1 : 2.5 and coloured to match the stone.
- 3.3 The lettering on the cement repairs was traced for copying and then the cement was removed. The damaged areas were then repaired as above and the missing lettering cut into the mortar. The word 'cause' is clearly incorrect, as it does not fill the available space, and it should probably read 'service', but we could only reproduce what was already there. (see photos)
- 3.4 Lettering was then repainted, firstly with 'Keim' mineral paint, then with an oil-based gloss paint, retrieving eroded letters.

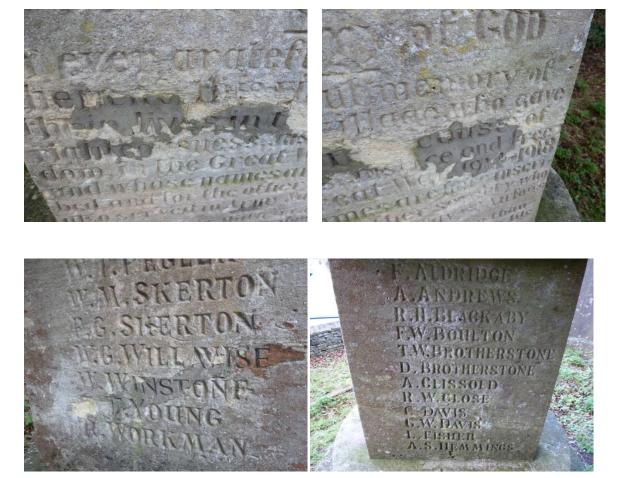
DAMAGE ON FRONT AND SIDES
